**Flood Control Project Maintenance
Levee Inspections**
LMA District Cover Sheet
Spring 2018 Levee Inspection Results

Sacramento Maintenance Yard Maintenance Area 0009

Spring 2018 Levee Inspection Results

Waterway	Bank	Unit Miles
Unit No. 01 Sacramento River	Left	19.35

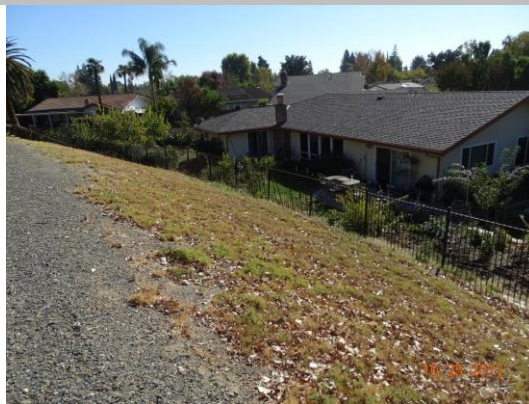
Photo 1 of 1 : SP_2018_MA0009_201_44_20180306_00031.jpg

LM Start	3.09	Rating **	M	Issue No.	44
LM End	3.11	Issue Type +	En	Location *	LS
Category	Earthen Levee			GPS Latitude/Longitude	
				Start	End
Item	Encroachments			38.515568 °	38.515475 °
				-121.540004 °	-121.540503 °
DWR ID	DWR_MA0009_01_f_2017_44				
Comment Code					
FE : Fence					
Inspector Comment

View of fence at landside toe. Fall 2017.

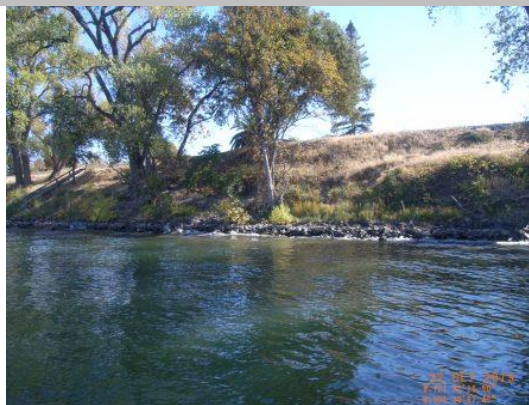
LM Start	3.09	Rating **	M	Issue No.	4
LM End	3.12	Issue Type +	Ma	Location *	WS
Category	Supplemental			GPS Latitude/Longitude	
				Start	End
Item	2015 USACE Erosion Survey, DRAFT			38.515887 °	38.515794 °
				-121.540174 °	-121.540713 °
DWR ID	DWR_MA0009_01_s _ 2016_4				
Comment Code					
Inspector Comment					
2010 - Small section of slumping, can be fixed with maintenance.					
2011 - Freshly fallen tree and minor new toe erosion. 2015: No					
observed changes. [2015 Site ID: SAC_52-7_L]

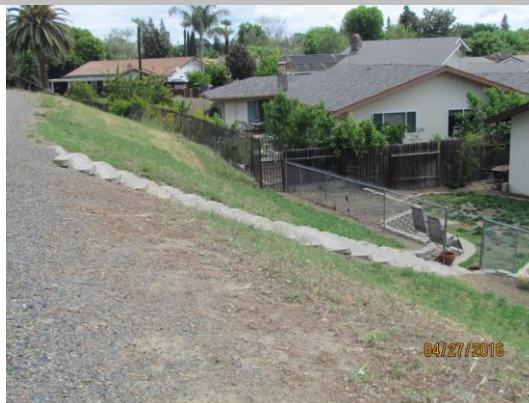
Photo 1 of 1 : SP_2018_MA0009_201_62_20180306_00036.jpg

LM Start	3.12	Rating **	M	Issue No.	62
LM End	3.12	Issue Type +	En	Location *	LS
Category	Earthen Levee			GPS Latitude/Longitude	
				Start	End
Item	Encroachments			38.515481 °	38.515481 °
				-121.540605 °	-121.540605 °
DWR ID	DWR_MA0009_01_s _ 2012_62				
Comment Code					
RW : Retaining Wall					
Inspector Comment					
Stairs and landscaping are permitted under Permit 18270 and 7525. Retaining wall is an illegal encroachment.

View of the steps on the slope and the retaining wall at the toe of the levee on the landward side looking upstream. Spring 2016.

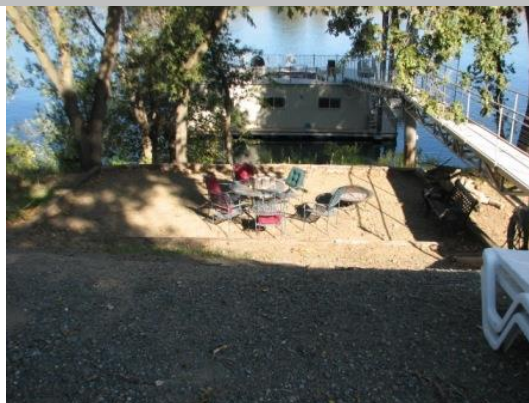
Photo 1 of 1 : SP_2018_MA0009_201_165_20180306_00118.jpg

LM Start	3.18	Rating **	M	Issue No.	165
LM End	3.18	Issue Type +	En	Location *	WS
Category	Earthen Levee			GPS Latitude/Longitude	
				Start	End
Item	Encroachments			38.515257 °	38.515257 °
				-121.541667 °	-121.541667 °
DWR ID	DWR_MA0009_01_s_2013_165				
Comment Code					
EQ : Equipment					
Inspector Comment					
Decomposed patio, tables, and chairs are on the berm of the watereward side of the levee.

A decomposed granite patio is on the berm. Fall 2013

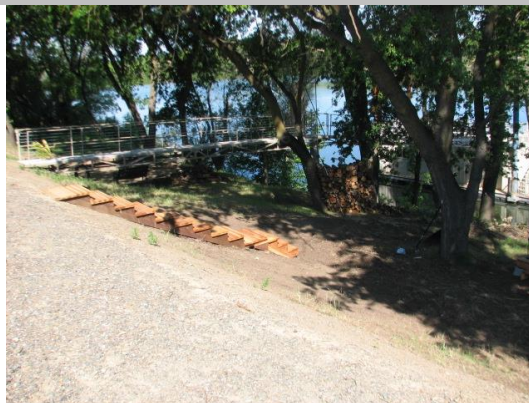
Photo 1 of 3 : SP_2018_MA0009_201_299_20180306_00234.jpg

LM Start	3.18	Rating **	M	Issue No.	299
LM End	3.18	Issue Type +	En	Location *	WS
Category	Earthen Levee			GPS Latitude/Longitude	
				Start	End
Item	Encroachments			38.515255 °	38.515255 °
				-121.541672 °	-121.541672 °
DWR ID	DWR_MA0009_01_s_2014_299				
Comment Code					
ST : Stairway					
Inspector Comment					
Steps, decking plus firewood stacked up. Need to get a permit. Stairway does not have permit but does not inhibit emergency operations.

New steps on the waterside slope. Spring 2014

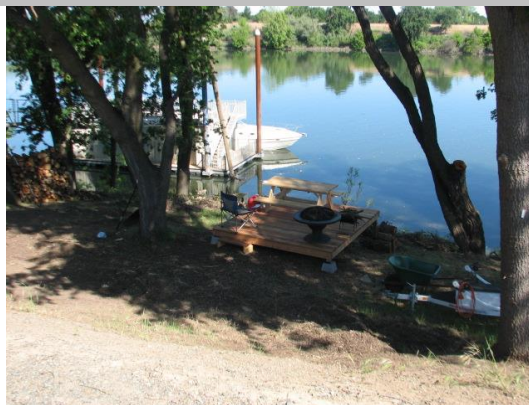
Photo 3 of 3 : SP_2018_MA0009_201_299_20180306_00236.jpg

A new deck has been added to the waterside berm. Spring 2014

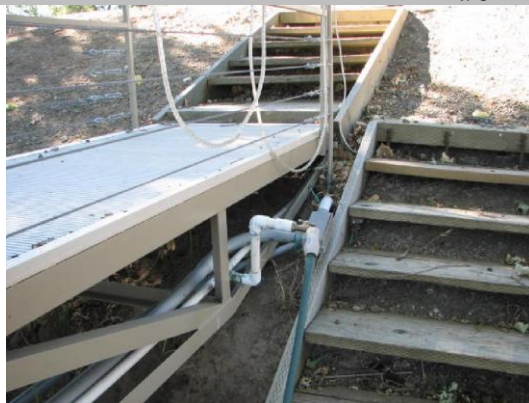
Photo 1 of 2 : UCIP_SP_2018_5860_8946.jpg

LM Start	3.19	Rating **	M	Issue No.	1787
LM End	3.19	Issue Type +	En	Location *	
Category	Supplemental			GPS Latitude/Longitude	
				Start	End
Item	DWR UCIP Field Study			38.515210 °	38.515210 °
				-121.541840 °	-121.541840 °
DWR ID					
Comment Code					
Inspector Comment					
FS_ID:5860 DS_ID:18909 EP_NO: N/A Repair Type: Non-Urgent Crossing Status: Found UCIP Comments: No permit identified for this crossing. This pipe was not part of the upgrade to the pier/walkway under Permit No. 17904. Nor was it part of the pier before the upgrade. FIELD_STRUCT_DESC: 1-inch polyvinyl chloride (PVC) water line through the levee, 1.5 feet below the crown. Hose bib attached to downstream side of boat ramp/pier, 50 feet upstream from pipe crossing. FS Date: 6/20/2012 10:14:00 AM

Pipes visible on downstream side of pier walkway.

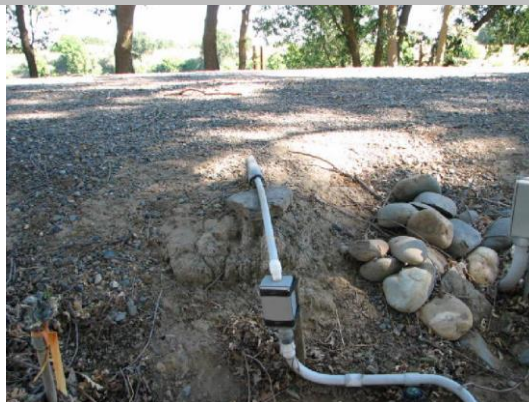
Photo 2 of 2 : UCIP_SP_2018_5856_8937.jpg

LM Start	3.19	Rating **	M	Issue No.	1788
LM End	3.19	Issue Type +	En	Location *	
Category	Supplemental			GPS Latitude/Longitude	
				Start	End
Item	DWR UCIP Field Study			38.515210 °	38.515210 °
				-121.541840 °	-121.541840 °
DWR ID					
Comment Code					
Inspector Comment					
FS_ID:5856 DS_ID:18910 EP_NO: N/A Repair Type: Non-Urgent Crossing Status: Found UCIP Comments: No permit identified for this crossing. FIELD_STRUCT_DESC: 2-inch galvanized steel electrical conduit through the levee, 0.5 feet below the crown. 0.75-inch polyvinyl chloride (PVC) electrical conduit running through it. FS Date: 6/20/2012 10:18:37 AM

Galvanized steel pipe with pvc electrical conduit running through it, LS shoulder 50-feet downstream from pier/ramp.

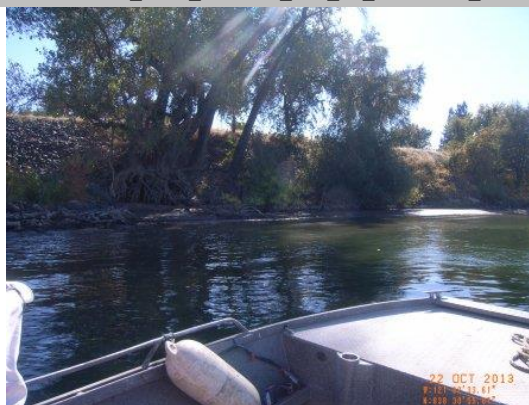
Photo 1 of 2 : SP_2018_MA0009_201_21_20180306_00016.jpg

LM Start	3.24	Rating **	M	Issue No.	21
LM End	3.26	Issue Type +	Ma	Location *	WS
Category	Supplemental			GPS Latitude/Longitude	
				Start	End
Item	2015 USACE Erosion Survey, DRAFT			38.515300 °	38.515184 °
				-121.542755 °	-121.543136 °
DWR ID	DWR_MA0009_01_s_2016_21				
Comment Code					
Inspector Comment					
2004 - A large tree cave was identified. 2005 - Site repaired. 2010 - At the downstream end of the repair at 52.5, bad transition is inducing further erosion. 2011 - Minor new erosion on bank. 2015: No observed changes. [2015 Site ID: SAC_52-4_L]

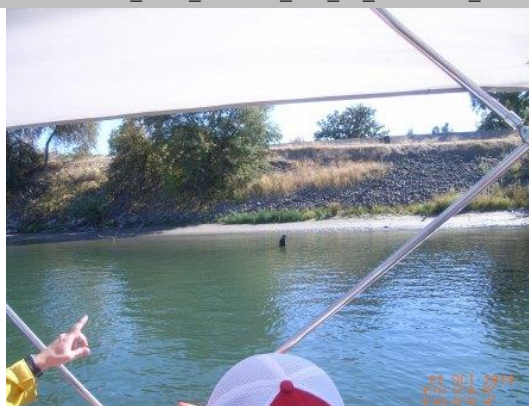
Photo 2 of 2 : SP_2018_MA0009_201_21_20180306_00017.jpg

LM Start	3.24	Rating **	M	Issue No.	21 (cont)
LM End	3.26	Issue Type +	Ma	Location *	WS
Category	Supplemental			GPS Latitude/Longitude	
				Start	End
Item	2015 USACE Erosion Survey, DRAFT			38.515300 °	38.515184 °
				-121.542755 °	-121.543136 °
DWR ID	DWR_MA0009_01_s_2016_21				
Comment Code					
Inspector Comment					
2004 - A large tree cave was identified. 2005 - Site repaired. 2010 - At the downstream end of the repair at 52.5, bad transition is inducing further erosion. 2011 - Minor new erosion on bank. 2015: No observed changes. [2015 Site ID: SAC_52-4_L]

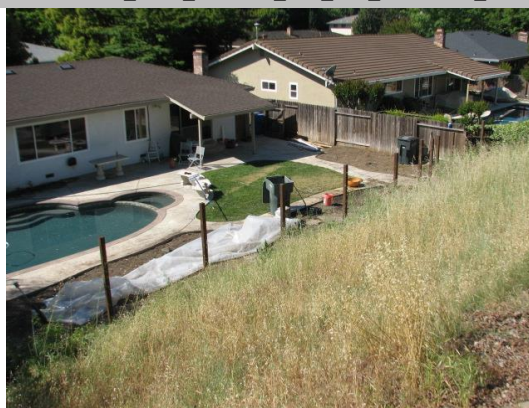
Photo 1 of 3 : SP_2018_MA0009_201_300_20180306_00237.jpg

LM Start	3.25	Rating **	M	Issue No.	300
LM End	3.25	Issue Type +	En	Location *	LS
Category	Earthen Levee			GPS Latitude/Longitude	
				Start	End
Item	Encroachments			38.514995 °	38.514995 °
				-121.542869 °	-121.542869 °
DWR ID	DWR_MA0009_01_s_2014_300				
Comment Code					
FE : Fence					
Inspector Comment

A wooden fence is being installed along the toe of the levee. Spring 2014

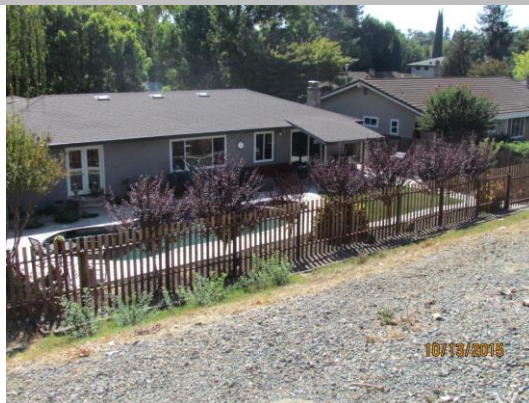
Photo 3 of 3 : SP_2018_MA0009_201_300_20180306_00239.jpg

View of the new fence along the levee toe on the landward side of the levee. Fall 2015.

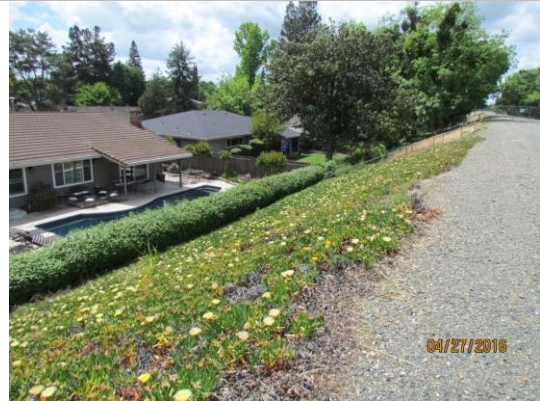
Photo 1 of 1 : SP_2018_MA0009_201_68_20180306_00037.jpg

LM Start	3.25	Rating **	U	Issue No.	68
LM End	3.26	Issue Type +	En	Location *	LS
Category	Earthen Levee			GPS Latitude/Longitude	
				Start	End
Item	Vegetation			38.514957 °	38.514916 °
				-121.542969 °	-121.543148 °
DWR ID	DWR_MA0009_01_s_2012_68				
Comment Code					
V6 : Landscaping					
Inspector Comment					
Ice plants, fence, and steps are permitted by Permit 8108-A and 8108-B. Vegetation on fence blocks visibility.

View of the groundcover and vines growing on the fence on the landward side of the levee looking downstream. Spring 2016.

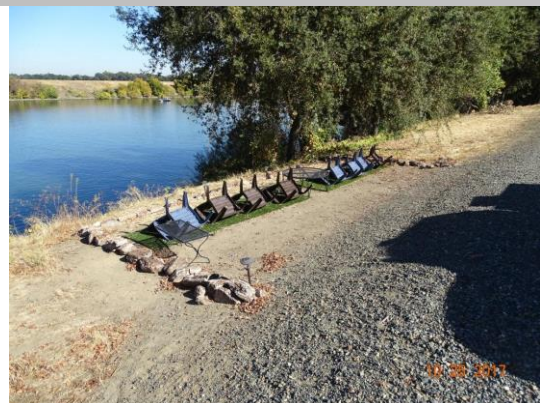
Photo 1 of 1 : SP_2018_MA0009_201_347_20180306_00282.jpg

LM Start	3.25	Rating **	M	Issue No.	347
LM End	3.25	Issue Type +	En	Location *	WS
Category	Earthen Levee			GPS Latitude/Longitude	
				Start	End
Item	Encroachments			38.514947 °	38.514947 °
				-121.543003 °	-121.543003 °
DWR ID	DWR_MA0009_01_f_2017_347				
Comment Code					
DE : Debris					
Inspector Comment					
Chairs, table, and rocks placed on waterside berm.

View of chairs, table, and rocks on waterside berm. Fall 2017.

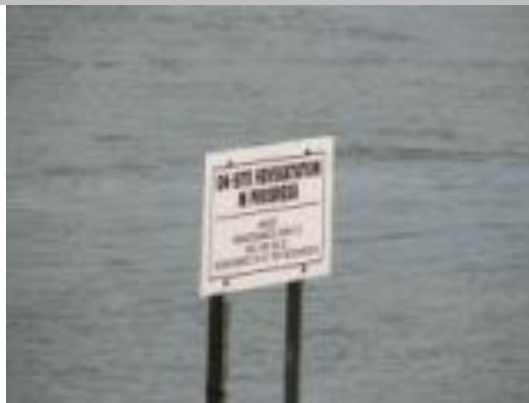
Photo 1 of 2 : SP_2018_MA0009_201_100_20180306_00058.jpg

LM Start	3.30	Rating **	A/W	Issue No.	100
LM End	3.52	Issue Type +	En	Location *	WS
Category	Earthen Levee			GPS Latitude/Longitude	
				Start	End
Item	Vegetation			38.514757 °	38.513647 °
				-121.543781 °	-121.547648 °
DWR ID	DWR_MA0009_01_s_2012_100				
Comment Code					
V8 : Environmental Requirements.					
Inspector Comment

A revegetation site. Photo taken spring 2012.

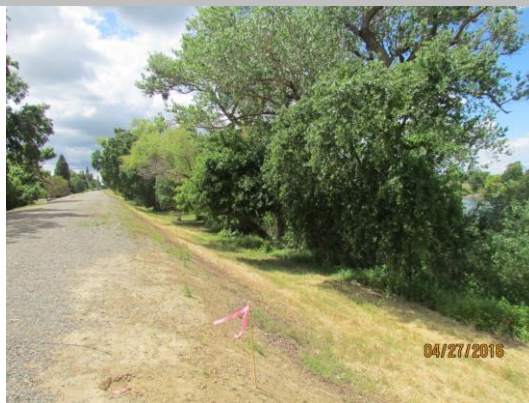
Photo 2 of 2 : SP_2018_MA0009_201_100_20180306_00059.jpg

View of the revegetation site on the berm of the waterward side of the levee looking downstream. Spring 2016.

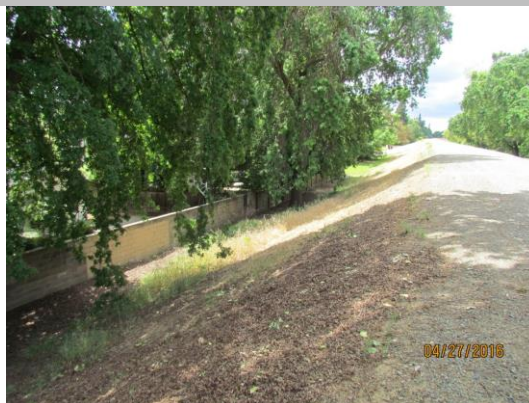
Photo 1 of 1 : SP_2018_MA0009_201_73_20180306_00042.jpg

LM Start	3.31	Rating **	U	Issue No.	73
LM End	3.34	Issue Type +	En	Location *	LS
Category	Earthen Levee			GPS Latitude/Longitude	
				Start	End
Item	Encroachments			38.514718 °	38.514555 °
				-121.543961 °	-121.544552 °
DWR ID	DWR_MA0009_01_s_2012_73				
Comment Code					
FE : Fence					
Inspector Comment

View of the wood and block fence at the toe of the levee on the landward side looking downstream. Spring 2016.

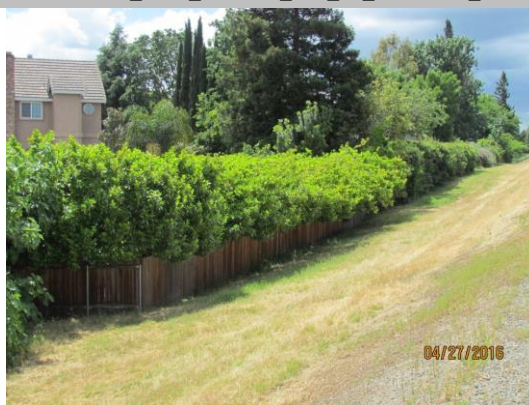
Photo 1 of 1 : SP_2018_MA0009_201_74_20180306_00043.jpg

LM Start	3.57	Rating **	U	Issue No.	74
LM End	3.59	Issue Type +	En	Location *	LS
Category	Earthen Levee			GPS Latitude/Longitude	
				Start	End
Item	Encroachments			38.513416 °	38.513337 °
				-121.548463 °	-121.548820 °
DWR ID	DWR_MA0009_01_s _ 2012_74				
Comment Code					
FE : Fence					
Inspector Comment

View of the wooden fence and tall shrubs at the toe of the levee on the landward side of the levee looking downstream. Spring 2016.

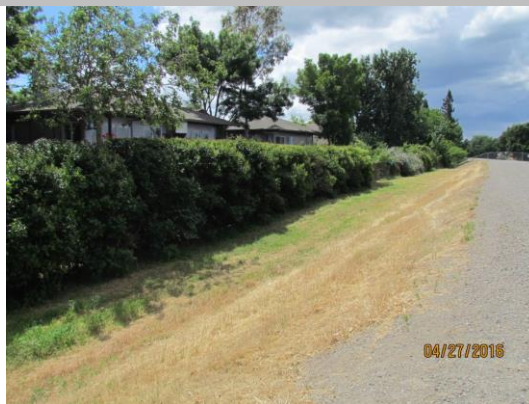
Photo 1 of 1 : SP_2018_MA0009_201_75_20180306_00044.jpg

LM Start	3.59	Rating **	U	Issue No.	75
LM End	3.61	Issue Type +	En	Location *	LS
Category	Earthen Levee			GPS Latitude/Longitude	
				Start	End
Item	Vegetation			38.513330 °	38.513236 °
				-121.548838 °	-121.549264 °
DWR ID	DWR_MA0009_01_s _ 2018_75				
Comment Code					
V6 : Landscaping					
Inspector Comment					
The hedges blocks the view of the levee berm.

View of the hedge on the berm of the levee on the landward side looking downstream. Spring 2016.

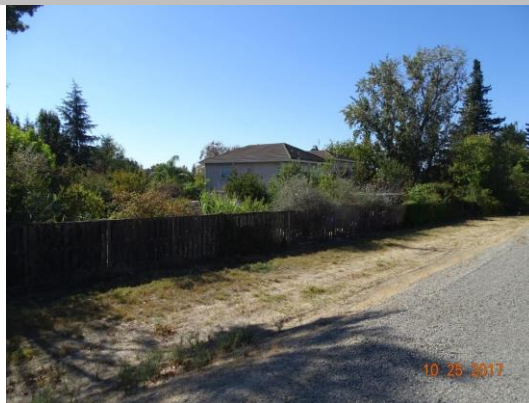
Photo 1 of 1 : SP_2018_MA0009_201_76_20180306_00045.jpg

LM Start	3.61	Rating **	U	Issue No.	76
LM End	3.66	Issue Type +	En	Location *	LS
Category	Earthen Levee			GPS Latitude/Longitude	
				Start	End
Item	Encroachments			38.513244 °	38.513066 °
				-121.549267 °	-121.550029 °
DWR ID	DWR_MA0009_01_f _ 2017_76				
Comment Code					
FE : Fence					
Inspector Comment					
Wooden fence on landside berm.

View of fence at landside toe. Fall 2017.

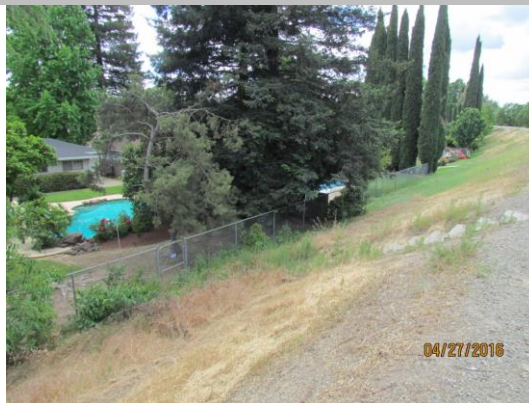
Photo 1 of 1 : SP_2018_MA0009_201_80_20180306_00046.jpg

LM Start	3.71	Rating **	M	Issue No.	80
LM End	3.71	Issue Type +	En	Location *	LS
Category	Earthen Levee			GPS Latitude/Longitude	
				Start	End
Item	Vegetation			38.512753 °	38.512753 °
				-121.550856 °	-121.550856 °
DWR ID	DWR_MA0009_01_s_2012_80				
Comment Code					
V6 : Landscaping					
Inspector Comment					
Trees need to be thinned and trimmed for visibility.

View of the fence and trees on the landward side of the levee looking downstream. Spring 2016.

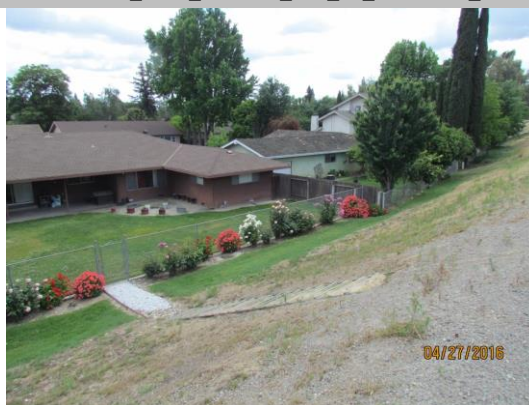
Photo 1 of 1 : SP_2018_MA0009_201_82_20180306_00047.jpg

LM Start	3.74	Rating **	M	Issue No.	82
LM End	3.74	Issue Type +	En	Location *	LS
Category	Earthen Levee			GPS Latitude/Longitude	
				Start	End
Item	Encroachments			38.512507 °	38.512507 °
				-121.551334 °	-121.551334 °
DWR ID	DWR_MA0009_01_s_2012_82				
Comment Code					
ST : Stairway					
Inspector Comment					
Steps are not permitted.

View of the steps and landscaping at the toe of the levee on the landward side looking downstream. Spring 2016.

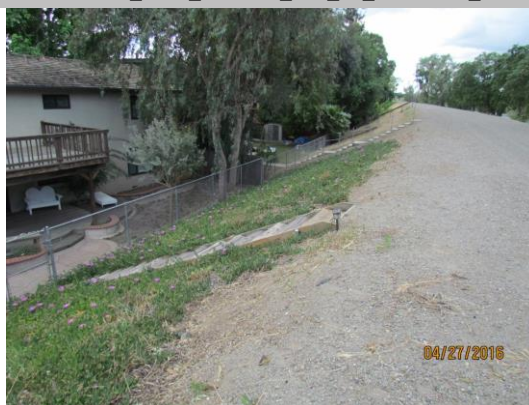
Photo 1 of 1 : SP_2018_MA0009_201_85_20180306_00049.jpg

LM Start	3.78	Rating **	M	Issue No.	85
LM End	3.78	Issue Type +	En	Location *	LS
Category	Earthen Levee			GPS Latitude/Longitude	
				Start	End
Item	Vegetation			38.512090 °	38.512090 °
				-121.551958 °	-121.551958 °
DWR ID	DWR_MA0009_01_s_2012_85				
Comment Code					
V6 : Landscaping					
Inspector Comment					
Fence and stairs are permitted by Permit 12169 and 12169-A. Groundcover does not seem to be permitted and blocks visibility on the slope.

View of the groundcover on the landward side of the levee looking downstream. Spring 2016.

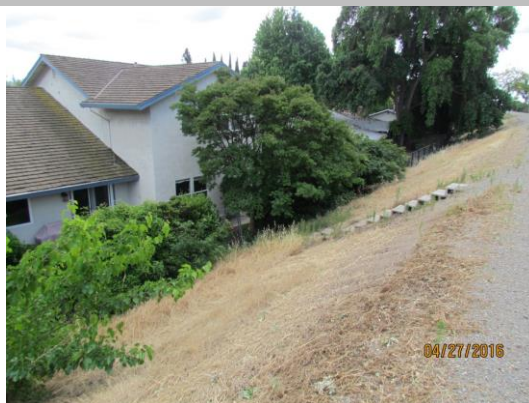
Photo 1 of 1 : SP_2018_MA0009_201_88_20180306_00051.jpg

LM Start	3.83	Rating **	M	Issue No.	88
LM End	3.83	Issue Type +	En	Location *	LS
Category	Earthen Levee			GPS Latitude/Longitude	
				Start	End
Item	Vegetation			38.511605 °	38.511605 °
				-121.552533 °	-121.552533 °
DWR ID	DWR_MA0009_01_s_2012_88				
Comment Code					
V6 : Landscaping					
Inspector Comment					
The fence and steps are permitted through Permit 12408-A. Vegetation is on the fence and blocks visibility.

View of the landscaping at the toe of the levee on the landward side of the levee looking downstream. Spring 2016.

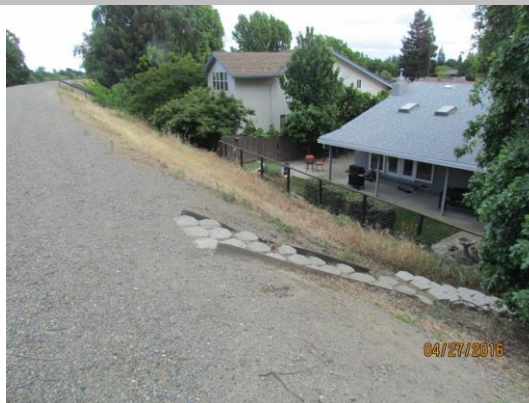
Photo 1 of 1 : SP_2018_MA0009_201_89_20180306_00052.jpg

LM Start	3.85	Rating **	M	Issue No.	89
LM End	3.85	Issue Type +	En	Location *	LS
Category	Earthen Levee			GPS Latitude/Longitude	
				Start	End
Item	Encroachments			38.511372 °	38.511372 °
				-121.552767 °	-121.552767 °
DWR ID	DWR_MA0009_01_s_2012_89				
Comment Code					
ST : Stairway					
Inspector Comment					
Timber stairs are permitted through Permit 11977-B, but these stairs are concrete.

View of the steps on the landward side of the levee looking upstream. Spring 2016.

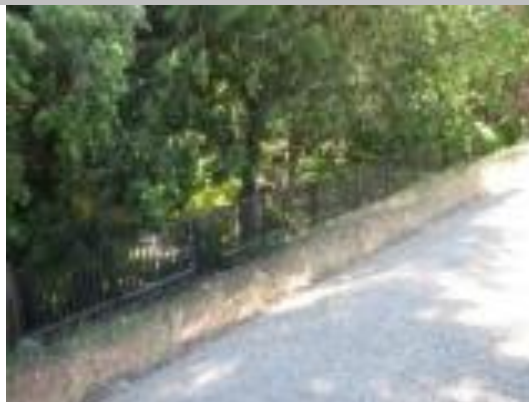
Photo 1 of 1 : SP_2018_MA0009_201_90_20180306_00053.jpg

LM Start	3.86	Rating **	M	Issue No.	90
LM End	3.86	Issue Type +	En	Location *	LS
Category	Earthen Levee			GPS Latitude/Longitude	
				Start	End
Item	Encroachments			38.511219 °	38.511219 °
				-121.552907 °	-121.552907 °
DWR ID	DWR_MA0009_01_s_2012_90				
Comment Code					
FE : Fence					
Inspector Comment					
Fence under permit 7334-A.

Wooden fence and landscape at toe. Spring 2013

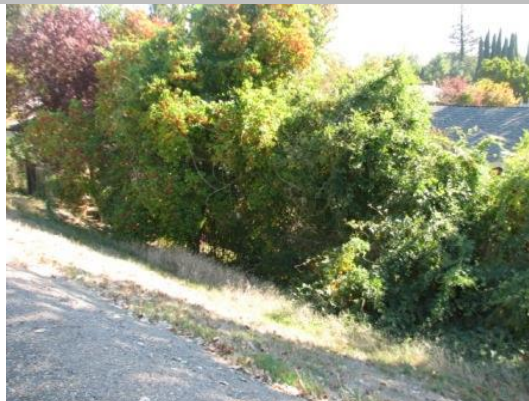
Photo 1 of 1 : SP_2018_MA0009_201_91_20180306_00054.jpg

LM Start	3.88	Rating **	M	Issue No.	91
LM End	3.88	Issue Type +	En	Location *	LS
Category	Earthen Levee			GPS Latitude/Longitude	
				Start	End
Item	Vegetation			38.511050 °	38.511050 °
				-121.553067 °	-121.553067 °
DWR ID	DWR_MA0009_01_s_2012_91				
Comment Code					
V6 : Landscaping					
Inspector Comment					
Tree needs to be thinned and trimmed for visibility.

Overgrown vegetation blocks visibility. Fall 2013

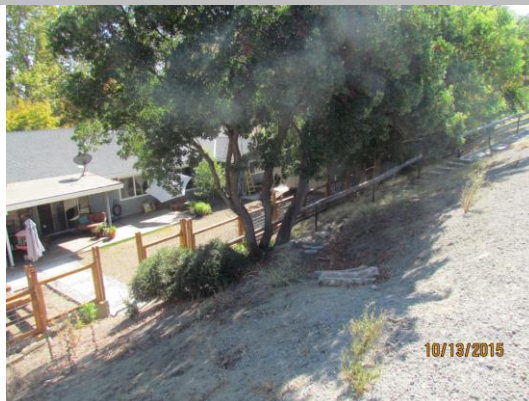
Photo 1 of 1 : SP_2018_MA0009_201_95_20180306_00055.jpg

LM Start	3.93	Rating **	M	Issue No.	95
LM End	3.93	Issue Type +	En	Location *	LS
Category	Earthen Levee			GPS Latitude/Longitude	
				Start	End
Item	Encroachments			38.510438 °	38.510438 °
				-121.553569 °	-121.553569 °
DWR ID	DWR_MA0009_01_s_2012_95				
Comment Code					
FE : Fence					
Inspector Comment					
Permit 11748 covers a wrought iron fence. The wrought iron fence has been replaced with a wooden see through fence.

View of the new fence at the toe of the levee on the landward side. Fall 2015.

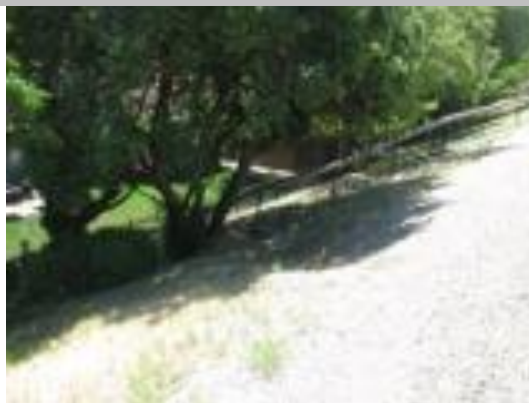
Photo 1 of 1 : SP_2018_MA0009_201_191_20180306_00146.jpg

LM Start	3.93	Rating **	M	Issue No.	191
LM End	3.93	Issue Type +	En	Location *	LS
Category	Earthen Levee			GPS Latitude/Longitude	
				Start	End
Item	Encroachments			38.510343 °	38.510343 °
				-121.553632 °	-121.553632 °
DWR ID	DWR_MA0009_01_f_2017_191				
Comment Code					
ST : Stairway					
Inspector Comment					
No permit on the stairs.

A new set of stairs with a handrail on the levee. Spring 2013

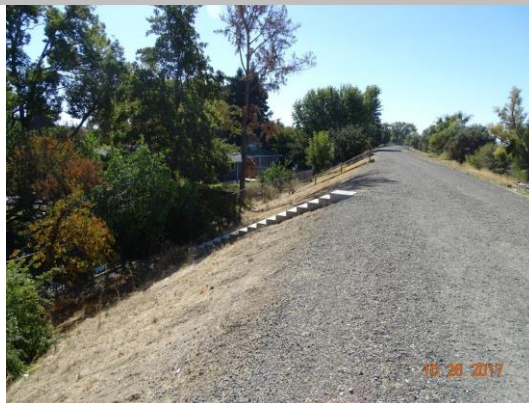
Photo 1 of 1 : SP_2018_MA0009_201_390_20180306_00310.jpg

LM Start	4.02	Rating **	M	Issue No.	390
LM End	4.03	Issue Type +	En	Location *	LS
Category	Earthen Levee			GPS Latitude/Longitude	
				Start	End
Item	Encroachments			38.509220 °	38.509008 °
				-121.554300 °	-121.554412 °
DWR ID	DWR_MA0009_01_f_2017_390				
Comment Code					
FE : Fence					
Inspector Comment					
Iron fence at landside toe and concrete steps on landside slope.

View of fence at toe and stairs on slope. Fall 2017.

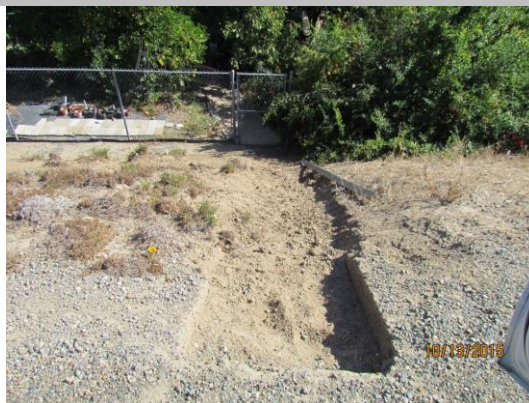
Photo 1 of 2 : SP_2018_MA0009_201_325_20180306_00259.jpg

LM Start	4.02	Rating **	U	Issue No.	325
LM End	4.02	Issue Type +	En	Location *	LS
Category	Earthen Levee			GPS Latitude/Longitude	
				Start	End
Item	Encroachments			38.509205 °	38.509205 °
				-121.554293 °	-121.554293 °
DWR ID	DWR_MA0009_01_f_2015_325				
Comment Code					
ST : Stairway					
Inspector Comment					
There appear to be a project for stairs on the landward slope.

The owner has cut into the levee slope to for stairs. Fall 2015.

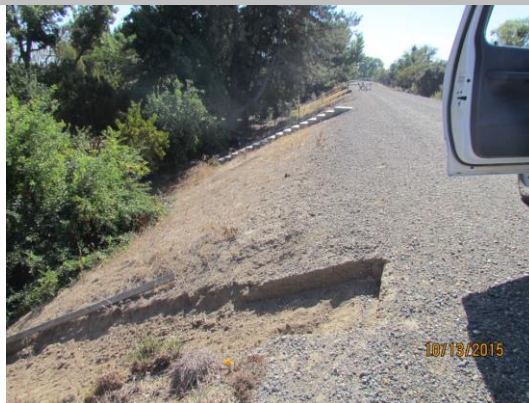
Photo 2 of 2 : SP_2018_MA0009_201_325_20180306_00260.jpg

LM Start	4.02	Rating **	U	Issue No.	325 (cont)
LM End	4.02	Issue Type +	En	Location *	LS

View of the excavated slope on the landward side of the levee looking downstream. Fall 2015.

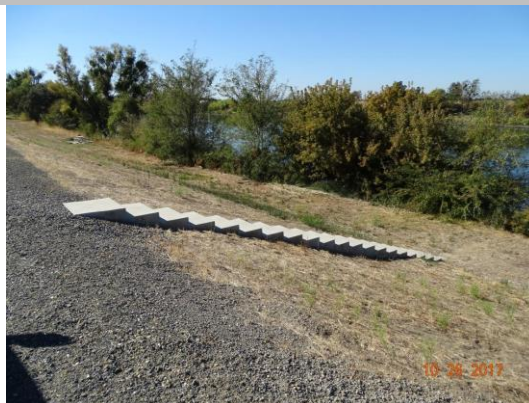
Photo 1 of 1 : SP_2018_MA0009_201_389_20180306_00309.jpg

LM Start	4.02	Rating **	M	Issue No.	389
LM End	4.02	Issue Type +	En	Location *	WS
Category	Earthen Levee			GPS Latitude/Longitude	
				Start	End
Item	Encroachments			38.509194 °	38.509194 °
				-121.554316 °	-121.554316 °
DWR ID	DWR_MA0009_01_f_2017_389				
Comment Code					
ST : Stairway					
Inspector Comment					
Concrete steps on the waterside slope.

View of steps on waterside slope. Fall 2017.

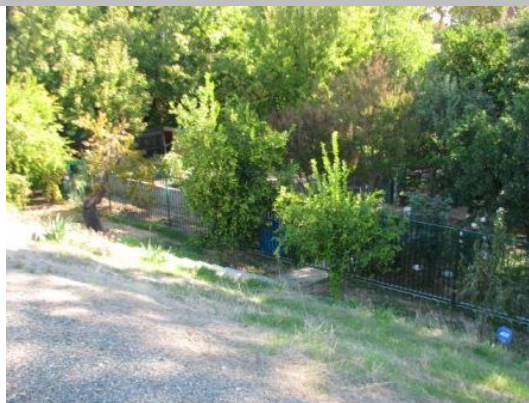
Photo 1 of 2 : SP_2018_MA0009_201_97_20180306_00056.jpg

LM Start	4.03	Rating **	M	Issue No.	97
LM End	4.03	Issue Type +	En	Location *	LS
Category	Earthen Levee			GPS Latitude/Longitude	
				Start	End
Item	Vegetation			38.509127 °	38.509127 °
				-121.554353 °	-121.554353 °
DWR ID	DWR_MA0009_01_f_2013_97				
Comment Code					
V6 : Landscaping					
Inspector Comment					
Fruit trees are at the toe of the levee.

Fruit trees and landscaping within the easement. Fall 2013

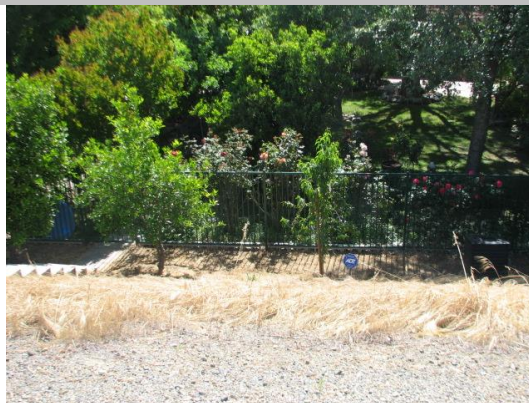
Photo 2 of 2 : SP_2018_MA0009_201_97_20180306_00057.jpg

LM Start	4.03	Rating **	M	Issue No.	97 (cont)
LM End	4.03	Issue Type +	En	Location *	LS

New fruit trees have been added to the toe of the levee. Spring 2014

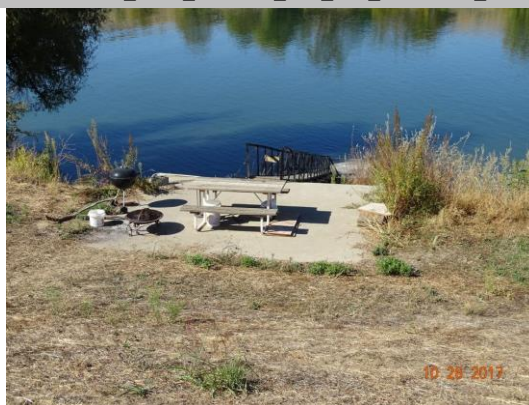
Photo 1 of 1 : SP_2018_MA0009_201_392_20180306_00311.jpg

LM Start	4.05	Rating **	M	Issue No.	392
LM End	4.05	Issue Type +	En	Location *	WS
Category	Earthen Levee			GPS Latitude/Longitude	
				Start	End
Item	Encroachments			38.508795 °	38.508795 °
				-121.554523 °	-121.554523 °
DWR ID	DWR_MA0009_01_f_2017_392				
Comment Code					
ST : Stairway					
Inspector Comment					
Stairway to boat dock, concrete slab, and picnic bench.

View of encroachments on waterside slope. Fall 2017.

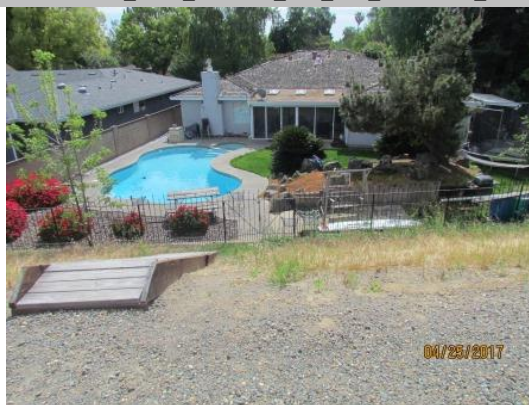
Photo 1 of 1 : SP_2018_MA0009_201_105_20180306_00062.jpg

LM Start	4.06	Rating **	M	Issue No.	105
LM End	4.06	Issue Type +	En	Location *	LS
Category	Earthen Levee			GPS Latitude/Longitude	
				Start	End
Item	Encroachments			38.508666 °	38.508666 °
				-121.554584 °	-121.554584 °
DWR ID	DWR_MA0009_01_s_2012_105				
Comment Code					
ST : Stairway					
Inspector Comment					
Steps, fence, and pool do not appear to be permitted.

View of steps, fence and landscape. Spring 2017

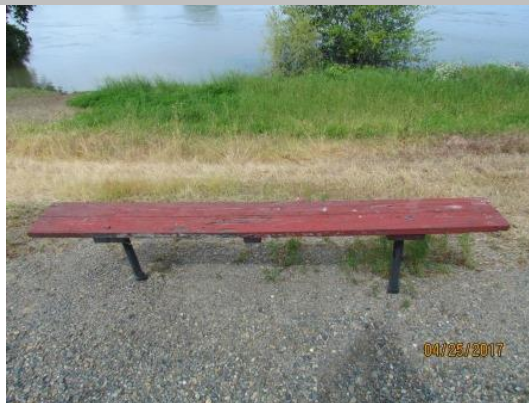
Photo 1 of 1 : SP_2018_MA0009_201_274_20180306_00218.jpg

LM Start	4.09	Rating **	M	Issue No.	274
LM End	4.09	Issue Type +	En	Location *	WS
Category	Earthen Levee			GPS Latitude/Longitude	
				Start	End
Item	Encroachments			38.508315 °	38.508315 °
				-121.554740 °	-121.554740 °
DWR ID	DWR_MA0009_01_s_2017_274				
Comment Code					
DE : Debris					
Inspector Comment					
Bench on waterside shoulder.

View of bench on waterside shoulder. Spring 2017.

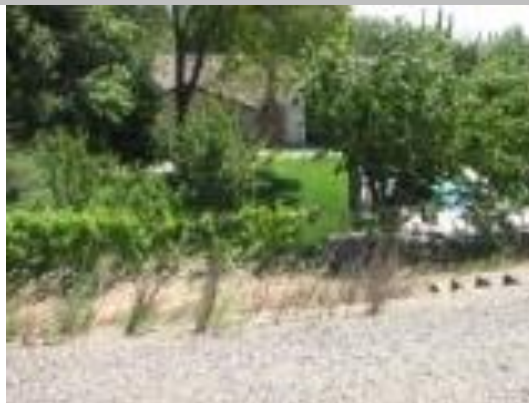
Photo 1 of 1 : SP_2018_MA0009_201_195_20180306_00148.jpg

LM Start	4.10	Rating **	M	Issue No.	195
LM End	4.10	Issue Type +	En	Location *	LS
Category	Earthen Levee			GPS Latitude/Longitude	
				Start	End
Item	Vegetation			38.508166 °	38.508166 °
				-121.554827 °	-121.554827 °
DWR ID	DWR_MA0009_01_s_2018_195				
Comment Code					
V6 : Landscaping					
Inspector Comment					
Vines on fence obstruct visibility.

Fence with grape vines growing on it. Spring 2013

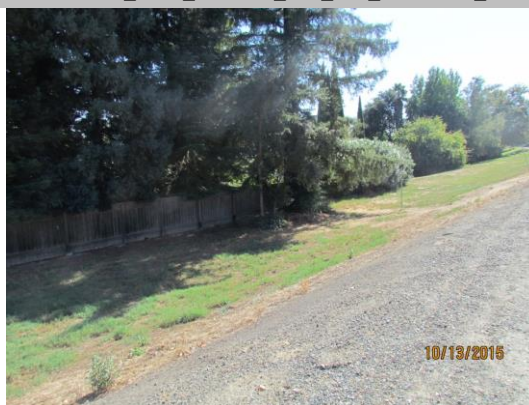
Photo 1 of 1 : SP_2018_MA0009_201_108_20180306_00065.jpg

LM Start	4.14	Rating **	M	Issue No.	108
LM End	4.15	Issue Type +	En	Location *	LS
Category	Earthen Levee			GPS Latitude/Longitude	
				Start	End
Item	Encroachments			38.507632 °	38.507409 °
				-121.555157 °	-121.555302 °
DWR ID	DWR_MA0009_01_s_2012_108				
Comment Code					
FE : Fence					
Inspector Comment					
Wooden fence on landside berm.

View of the fence on the landward side of the levee looking downstream. Fall 2015.

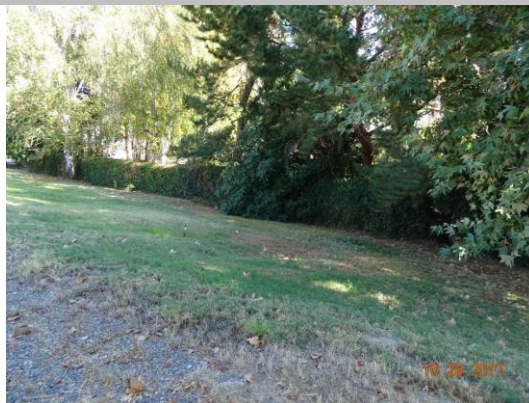
Photo 1 of 1 : SP_2018_MA0009_201_396_20180306_00312.jpg

LM Start	4.20	Rating **	U	Issue No.	396
LM End	4.22	Issue Type +	En	Location *	LS
Category	Earthen Levee			GPS Latitude/Longitude	
				Start	End
Item	Vegetation			38.506850 °	38.506568 °
				-121.555607 °	-121.555693 °
DWR ID	DWR_MA0009_01_f_2017_396				
Comment Code					
V6 : Landscaping					
Inspector Comment					
Vegetation on chain link fence blocks visibility.

View of vegetation on fence on landside. Fall 2017.

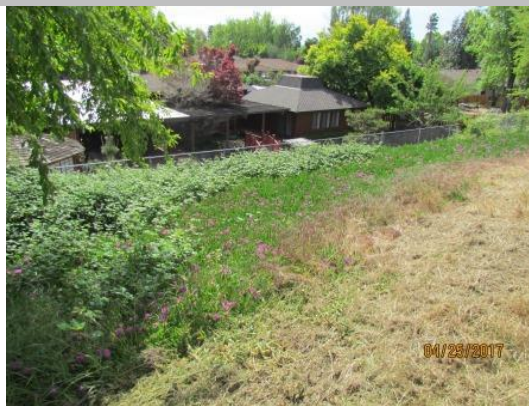
Photo 1 of 1 : SP_2018_MA0009_201_277_20180306_00219.jpg

LM Start	4.27	Rating **	U	Issue No.	277
LM End	4.27	Issue Type +	En	Location *	LS
Category	Earthen Levee			GPS Latitude/Longitude	
				Start	End
Item	Vegetation			38.505834 °	38.505834 °
				-121.555995 °	-121.555995 °
DWR ID	DWR_MA0009_01_s_2017_277				
Comment Code					
V6 : Landscaping					
Inspector Comment

View of vegetation on landside slope. Spring 2017.

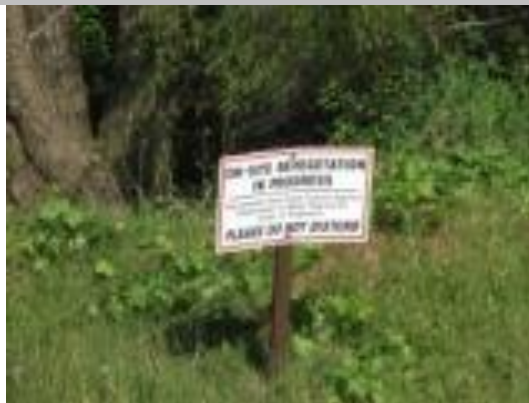
Photo 1 of 1 : SP_2018_MA0009_201_107_20180306_00063.jpg

LM Start	4.27	Rating **	A/W	Issue No.	107
LM End	4.36	Issue Type +	En	Location *	WS
Category	Earthen Levee			GPS Latitude/Longitude	
				Start	End
Item	Vegetation			38.505824 °	38.504553 °
				-121.555998 °	-121.556423 °
DWR ID	DWR_MA0009_01_s_2012_107				
Comment Code					
V8 : Environmental Requirements.					
Inspector Comment

A revegetation site. Photo taken spring 2012.

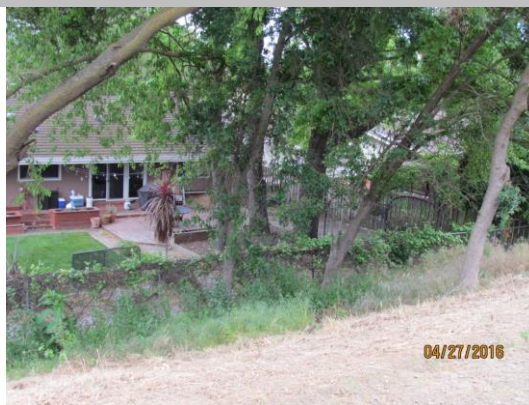
Photo 2 of 2 : SP_2018_MA0009_201_335_20180306_00272.jpg

LM Start	4.29	Rating **	M	Issue No.	335 (cont)
LM End	4.29	Issue Type +	En	Location *	LS

View of the vegetation on the landward side of the levee. Wild grapes have been cleared but there still seems to be vines on the fence. Spring 2016.

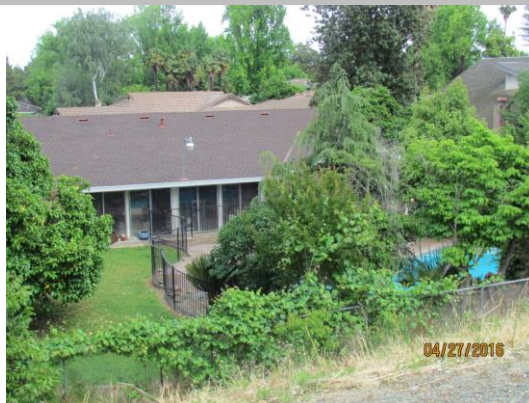
Photo 1 of 1 : SP_2018_MA0009_201_114_20180306_00068.jpg

LM Start	4.31	Rating **	M	Issue No.	114
LM End	4.31	Issue Type +	En	Location *	LS
Category	Earthen Levee			GPS Latitude/Longitude	
				Start	End
Item	Vegetation			38.505294 °	38.505294 °
				-121.556199 °	-121.556199 °
DWR ID	DWR_MA0009_01_s_2012_114				
Comment Code					
V6 : Landscaping					
Inspector Comment					
Trees and vegetation on fence blocks visibility. Trees need to be thinned and trimmed.

View of the fence and landscaping on the landward side of the levee.
Spring 2016.

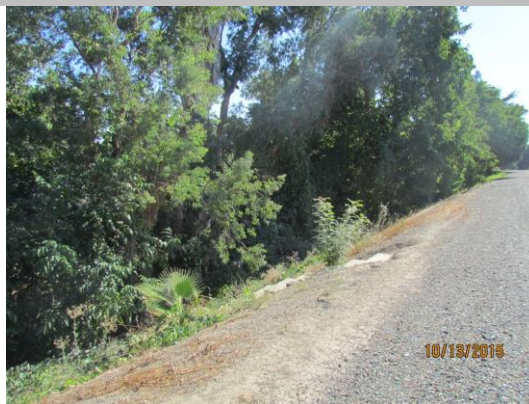
Photo 1 of 2 : SP_2018_MA0009_201_115_20180306_00069.jpg

LM Start	4.33	Rating **	M	Issue No.	115
LM End	4.33	Issue Type +	En	Location *	LS
Category	Earthen Levee			GPS Latitude/Longitude	
				Start	End
Item	Vegetation			38.505022 °	38.505022 °
				-121.556283 °	-121.556283 °
DWR ID	DWR_MA0009_01_s_2012_115				
Comment Code					
V6 : Landscaping					
Inspector Comment					
Trees need to be thinned and trimmed for visibility.

Perspective view of the landscaping on the landward side of the levee
looking downstream. Fall 2015.

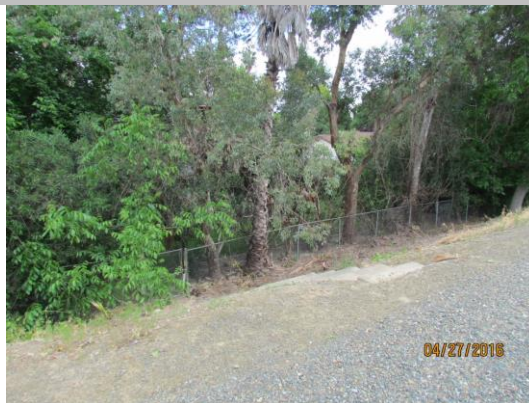
Photo 2 of 2 : SP_2018_MA0009_201_115_20180306_00070.jpg

LM Start	4.33	Rating **	M	Issue No.	115 (cont)	
LM End	4.33	Issue Type +	En	Location *	LS	
Category	Earthen Levee			GPS Latitude/Longitude		
				Start		End
Item	Vegetation			38.505022 °		38.505022 °
				-121.556283 °		-121.556283 °
DWR ID	DWR_MA0009_01_s _ 2012_115					
Comment Code						
V6 : Landscaping						
Inspector Comment						
Trees need to be thinned and trimmed for visibility.

View of the landscaping at the toe of the levee on the landward side.
Spring 2016.

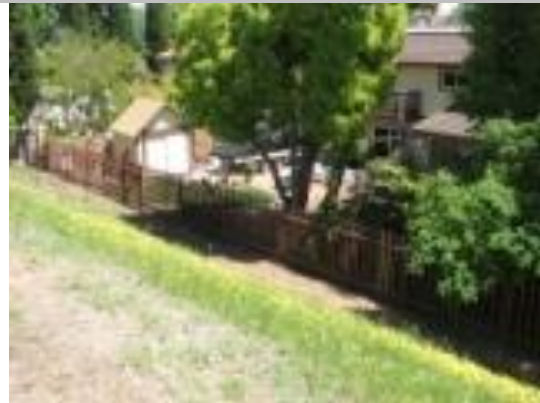
Photo 1 of 1 : SP_2018_MA0009_201_120_20180306_00071.jpg

LM Start	4.43	Rating **	M	Issue No.	120
LM End	4.43	Issue Type +	En	Location *	LS
Category	Earthen Levee			GPS Latitude/Longitude	
				Start	End
Item	Encroachments			38.503640 °	38.503640 °
				-121.556708 °	-121.556708 °
DWR ID	DWR_MA0009_01_s_2012_120				
Comment Code					
FE : Fence					
Inspector Comment					
Fence does not seem to be permitted.

Steps with handrail, fence and landscape with garden shed. Spring 2013

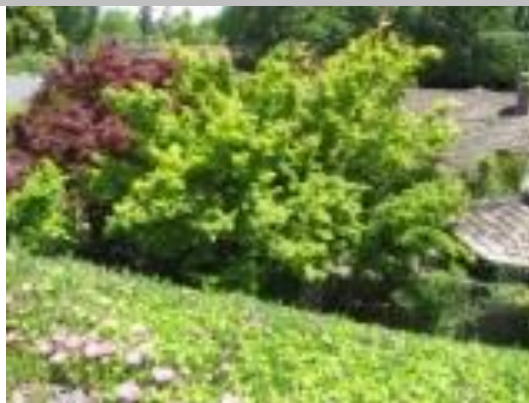
Photo 1 of 1 : SP_2018_MA0009_201_122_20180306_00073.jpg

LM Start	4.46	Rating **	M	Issue No.	122
LM End	4.46	Issue Type +	En	Location *	LS
Category	Earthen Levee			GPS Latitude/Longitude	
				Start	End
Item	Vegetation			38.503106 °	38.503106 °
				-121.556917 °	-121.556917 °
DWR ID	DWR_MA0009_01_s_2012_122				
Comment Code					
V6 : Landscaping					
Inspector Comment

Groundcover, fence and landscape makes it hard to see the toe. Spring 2013

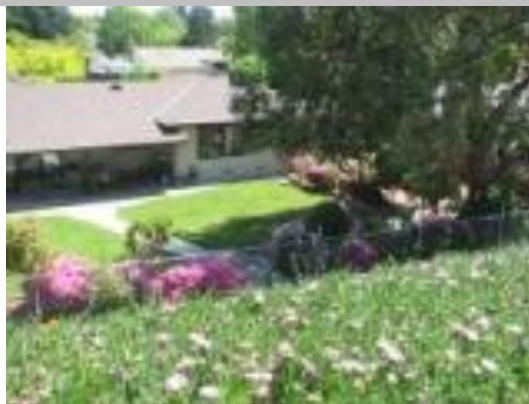
Photo 1 of 1 : SP_2018_MA0009_201_124_20180306_00074.jpg

LM Start	4.48	Rating **	M	Issue No.	124
LM End	4.48	Issue Type +	En	Location *	LS
Category	Earthen Levee			GPS Latitude/Longitude	
				Start	End
Item	Vegetation			38.502861 °	38.502861 °
				-121.557032 °	-121.557032 °
DWR ID	DWR_MA0009_01_s_2012_124				
Comment Code					
V6 : Landscaping					
Inspector Comment

Groundcover, fence and landscape. Spring 2013

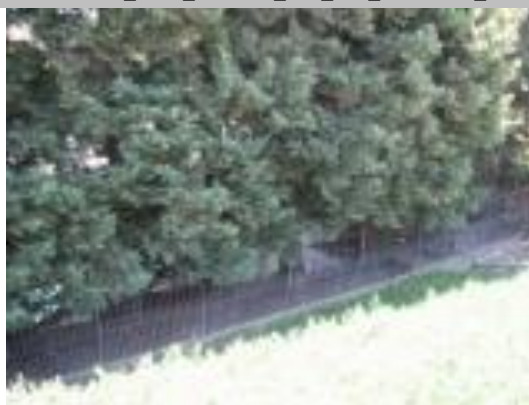
Photo 1 of 1 : SP_2018_MA0009_201_125_20180306_00075.jpg

LM Start	4.50	Rating **	M	Issue No.	125
LM End	4.50	Issue Type +	En	Location *	LS
Category	Earthen Levee			GPS Latitude/Longitude	
				Start	End
Item	Vegetation			38.502669 °	38.502669 °
				-121.557152 °	-121.557152 °
DWR ID	DWR_MA0009_01_s_2012_125				
Comment Code					
V6 : Landscaping					
Inspector Comment

Steps, fence and large redwood trees. Spring 2013

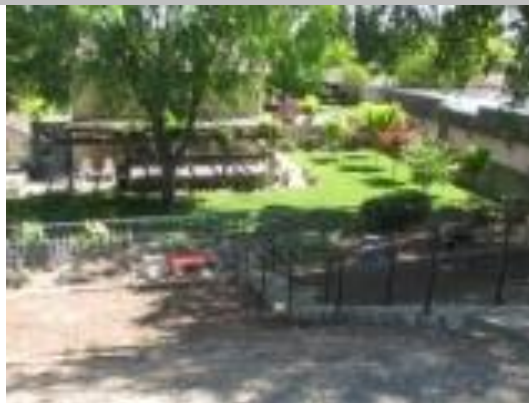
Photo 1 of 1 : SP_2018_MA0009_201_126_20180306_00076.jpg

LM Start	4.52	Rating **	M	Issue No.	126
LM End	4.52	Issue Type +	En	Location *	LS
Category	Earthen Levee			GPS Latitude/Longitude	
				Start	End
Item	Vegetation			38.502401 °	38.502401 °
				-121.557317 °	-121.557317 °
DWR ID	DWR_MA0009_01_s_2012_126				
Comment Code					
V6 : Landscaping					
Inspector Comment

Steps with a handrail, fence and landscape. Spring 2013

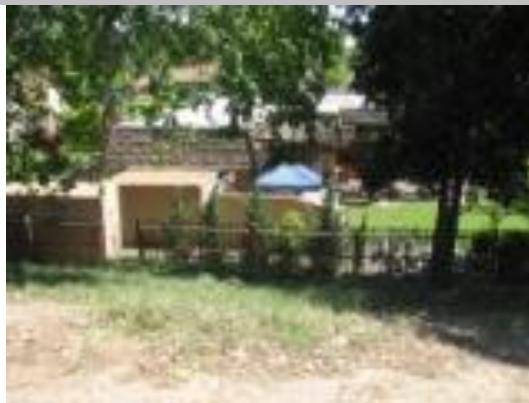
Photo 1 of 1 : SP_2018_MA0009_201_127_20180306_00077.jpg

LM Start	4.54	Rating **	M	Issue No.	127
LM End	4.54	Issue Type +	En	Location *	LS
Category	Earthen Levee			GPS Latitude/Longitude	
				Start	End
Item	Vegetation			38.502163 °	38.502163 °
				-121.557407 °	-121.557407 °
DWR ID	DWR_MA0009_01_s_2012_127				
Comment Code					
V6 : Landscaping					
Inspector Comment

Fence, landscape, and buildings at toe. Spring 2013

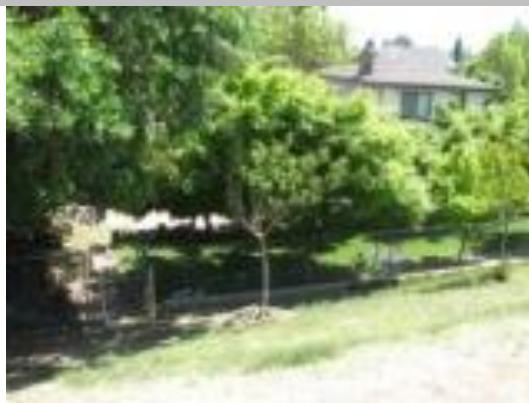
Photo 1 of 1 : SP_2018_MA0009_201_128_20180306_00078.jpg

LM Start	4.55	Rating **	M	Issue No.	128
LM End	4.55	Issue Type +	En	Location *	LS
Category	Earthen Levee			GPS Latitude/Longitude	
				Start	End
Item	Encroachments			38.501895 °	38.501895 °
				-121.557481 °	-121.557481 °
DWR ID	DWR_MA0009_01_s_2012_128				
Comment Code					
RW : Retaining Wall					
Inspector Comment

Trees on the slope, a retaining wall, fence and landscape. Spring 2013

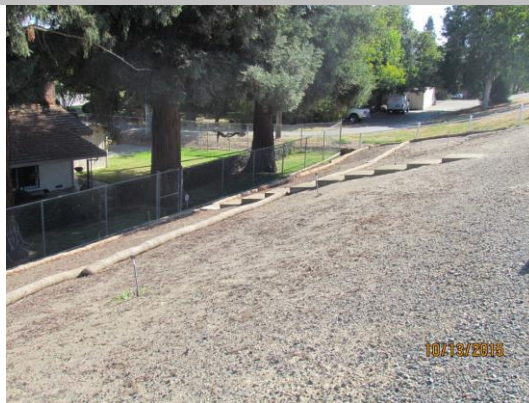
Photo 1 of 1 : SP_2018_MA0009_201_129_20180306_00079.jpg

LM Start	4.57	Rating **	M	Issue No.	129
LM End	4.57	Issue Type +	En	Location *	LS
Category	Earthen Levee			GPS Latitude/Longitude	
				Start	End
Item	Encroachments			38.501627 °	38.501627 °
				-121.557553 °	-121.557553 °
DWR ID	DWR_MA0009_01_s_2012_129				
Comment Code					
ST : Stairway					
Inspector Comment

View of the steps, fence and large trees at the toe of the levee on the landward side looking downstream. Fall 2015.

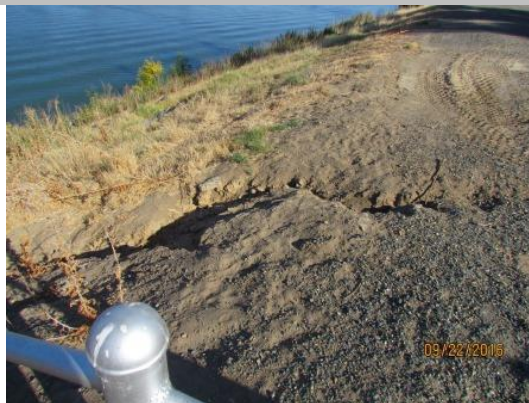
Photo 1 of 4 : SP_2018_MA0009_201_333_20180306_00267.jpg

LM Start	4.59	Rating **	M	Issue No.	333
LM End	4.59	Issue Type +	Ma	Location *	WS
Category	Earthen Levee			GPS Latitude/Longitude	
				Start	End
Item	Erosion / Bank Caving			38.501356 °	38.501356 °
				-121.557638 °	-121.557638 °
DWR ID	DWR_MA0009_01_s_2016_333				
Comment Code					
E2 : Schedule repair of erosion site prior to the next inspection.					
Inspector Comment

Erosion on WS slope. Fall 2016.

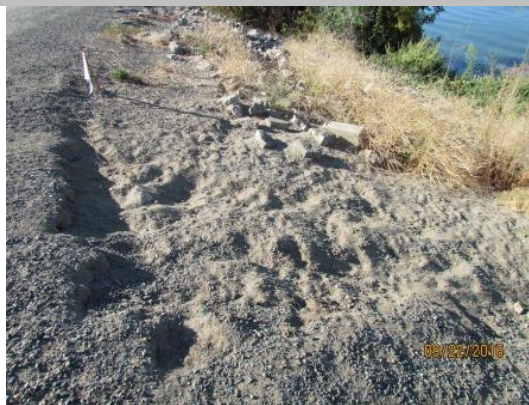
Photo 2 of 4 : SP_2018_MA0009_201_333_20180306_00268.jpg

Another view of erosion on WS slope. Fall 2016.

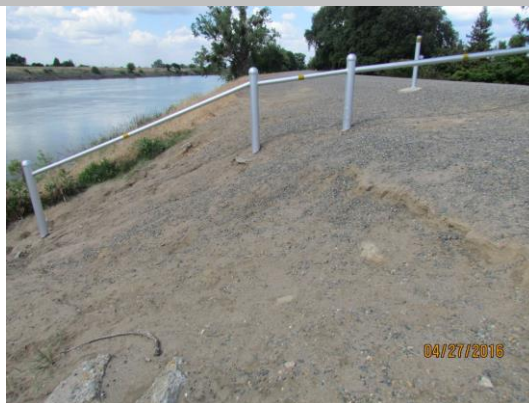
Photo 3 of 4 : SP_2018_MA0009_201_333_20180306_00269.jpg

Perspective view of the erosion site looking upstream. Spring 2016.

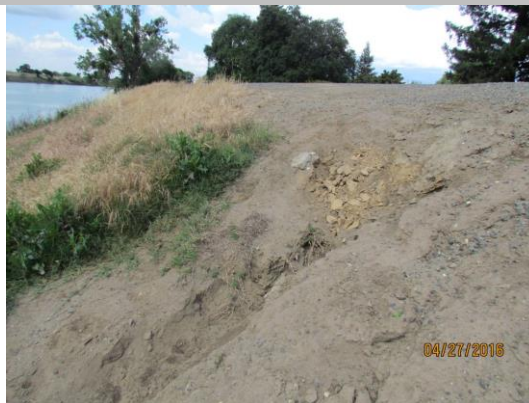
Photo 4 of 4 : SP_2018_MA0009_201_333_20180306_00270.jpg

LM Start	4.59	Rating **	M	Issue No.	333 (cont)	
LM End	4.59	Issue Type +	Ma	Location *	WS	
Category	Earthen Levee			GPS Latitude/Longitude		
				Start		End
Item	Erosion / Bank Caving			38.501356 °	38.501356 °	
				-121.557638 °	-121.557638 °	
DWR ID	DWR_MA0009_01_s_2016_333					
Comment Code						
E2 : Schedule repair of erosion site prior to the next inspection.						
Inspector Comment

Erosion is on the waterward slope of the levee. Spring 2016.

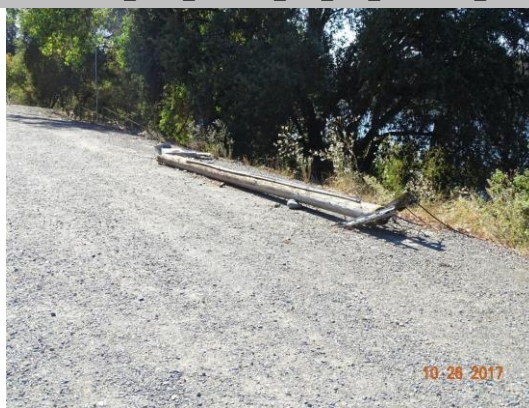
Photo 1 of 1 : SP_2018_MA0009_201_406_20180306_00313.jpg

LM Start	4.64	Rating **	M	Issue No.	406
LM End	4.64	Issue Type +	En	Location *	CR
Category	Earthen Levee			GPS Latitude/Longitude	
				Start	End
Item	Encroachments			38.500720 °	38.500720 °
				-121.557766 °	-121.557766 °
DWR ID	DWR_MA0009_01_f_2017_406				
Comment Code					
PO : Pole					
Inspector Comment					
Downed power pole on levee crown.

View of pole on crown. Fall 2017.

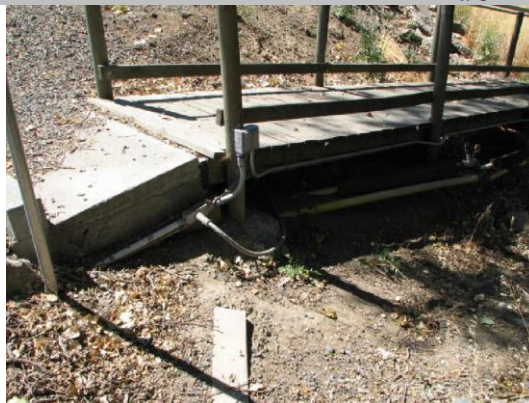
Photo 1 of 3 : UCIP_SP_2018_5760_8723.jpg

LM Start	4.65	Rating **	M	Issue No.	1790
LM End	4.65	Issue Type +	En	Location *	
Category	Supplemental			GPS Latitude/Longitude	
				Start	End
Item	DWR UCIP Field Study			38.500490 °	38.500490 °
				-121.557780 °	-121.557780 °
DWR ID					
Comment Code					
Inspector Comment					
FS_ID:5760 DS_ID:17418 EP_NO: N/A Repair Type: Non-Urgent Crossing Status: Indicator Found UCIP Comments: Locate and determine type of pipe abandonment. FIELD_STRUCT_DESC: *ABANDONED* 8-inch pipe through the levee, 3.4-feet below the crown. Constructed with 1-CM cut-off wall and a pump on the river side. Originally included in the O+M manual (1955). Levee log indicates this pipe abandoned in place. Two t-posts on LS toe may indicate location of pipe. Pictures in Permit 6525 clearly show this pipe just upstream of boat dock walkway. FS Date: 7/25/2012 9:10:00 AM

Boat dock ramp on WS shoulder where pipe may have come through.

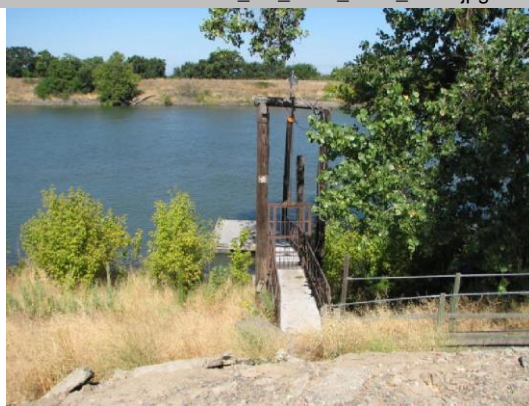
Photo 3 of 3 : UCIP_SP_2018_5760_8724.jpg

LM Start	4.65	Rating **	M	Issue No.	1790 (cont)	
LM End	4.65	Issue Type +	En	Location *		
Category	Supplemental			GPS Latitude/Longitude		
				Start	End	
Item	DWR UCIP Field Study			38.500490 °	38.500490 °	
				-121.557780 °	-121.557780 °	
DWR ID						
Comment Code						
Inspector Comment						
FS_ID:5760 DS_ID:17418 EP_NO: N/A Repair Type: Non-Urgent Crossing Status: Indicator Found UCIP Comments: Locate and determine type of pipe abandonment. FIELD_STRUCT_DESC: *ABANDONED* 8-inch pipe through the levee, 3.4-feet below the crown. Constructed with 1-CM cut-off wall and a pump on the river side. Originally included in the O+M manual (1955). Levee log indicates this pipe abandoned in place. Two t-posts on LS toe may indicate location of pipe. Pictures in Permit 6525 clearly show this pipe just upstream of boat dock walkway. FS Date: 7/25/2012 9:10:00 AM

Pier and floating dock near location of pipe.

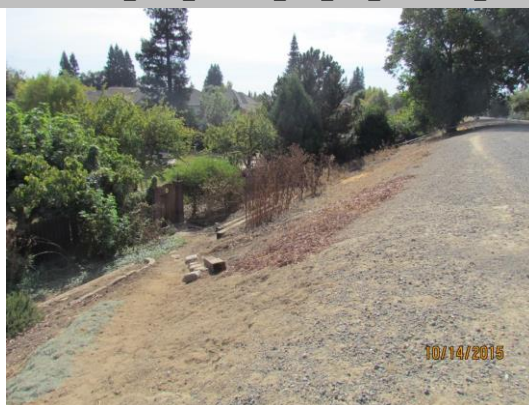
Photo 1 of 2 : SP_2018_MA0009_201_113_20180306_00066.jpg

LM Start	4.68	Rating **	M	Issue No.	113
LM End	4.68	Issue Type +	En	Location *	LS
Category	Earthen Levee			GPS Latitude/Longitude	
				Start	End
Item	Vegetation			38.500062 °	38.500062 °
				-121.557825 °	-121.557825 °
DWR ID	DWR_MA0009_01_s_2012_113				
Comment Code					
V6 : Landscaping					
Inspector Comment

View of the landscaping on the landward side of the levee looking downstream. Fall 2015.

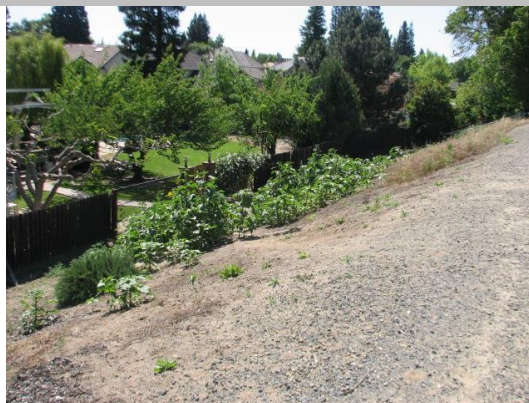
Photo 2 of 2 : SP_2018_MA0009_201_113_20180306_00067.jpg

The garden continues to be on the levee slope. Spring 2014
